THE RURAL LANDSCAPES OF LANE COUNTY, OREGON, THEN AND NOW:

A CASE STUDY OF THIRTY YEARS OF LANDSCAPE CHANGE

A TERMINAL PROJECT

Presented to the Historic Preservation Program, School of Architecture and Allied Arts  
and the Graduate School of the University of Oregon  
in partial fulfillment of the requirements  
for the degree of  
Master of Science

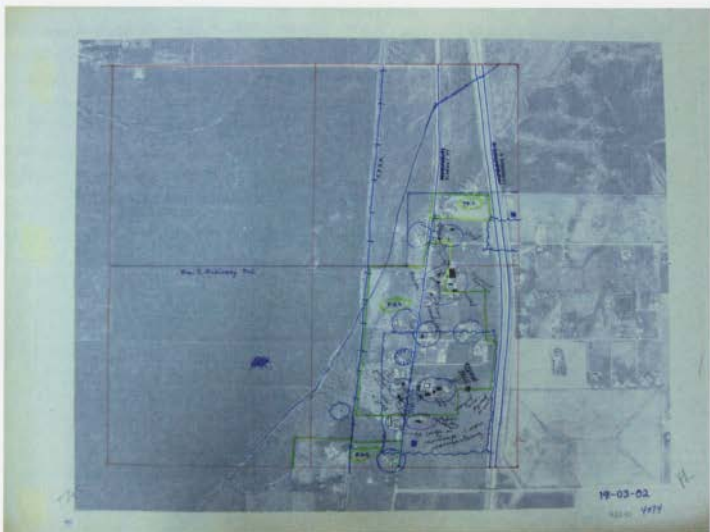
19S.03W.02 aerial photograph, 1983

| Characteristics | Features | Documentation |
|--|---|---|
| <p><b>Land Uses and Activities</b></p> <p>Includes: Fields, pastures, orchards, open range, terraces, commons, cemeteries, playing fields, parks, mining areas, quarries, and logging areas.</p> <p>*Describe principal and significant land uses</p> <p>*Identify the tangible features related to land uses by type, general location, dates of use, condition and related vegetation</p> <p>*Describe historic processes related to land use, such as mining, irrigation, lumbering, contour farming, or quarrying.</p> <p>*Point out obsolete historic operations, ongoing traditional practices, or modern adaptations related to significance.</p> <p>*Identify threats to integrity, and indicate their location, extant, and impact on historic integrity</p> <p>*Identify areas having major importance or predominance, by location and type, and classify historic or nonhistoric</p> | <p>Fields<br/>Pastures<br/>Orchards</p> | <p>A larger portion of this section is inaccessible, and from aerial photos can be seen that this area is made up of large areas of plowed fields.</p> <p>The most accessible portion is the land along Hwy 99.</p> <p>Land use consists of some livestock raising (alpacas and cattle), and agriculture (type ?)</p> <p>Smaller orchards, still being harvested?</p> <p>Residential</p> <p>Hwy 99 is both a historic feature and possibly a threat to integrity with increased traffic and use.</p> <p>Some specific locations in section may have significance, all 1930s:</p> <ol style="list-style-type: none"> <li>1.) The Old Hilltop Motel (transportation related)<br/>Buildings are still there, but now an apartment complex.</li> <li>2.) The extremely large barn just south of the hotel (commerce, agriculture)</li> <li>3.) Vernacular Gothic Revival house and small outbuildings</li> <li>4.) Filbert Orchard and associated buildings (just south of section boundary)</li> </ol> |

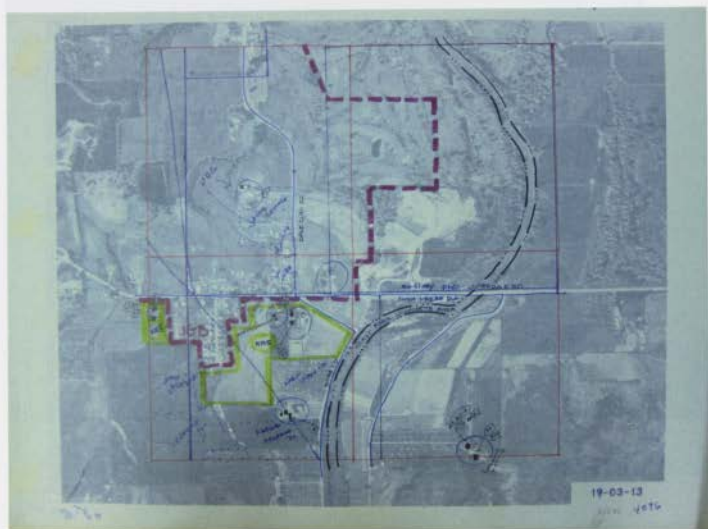
19S.03W.13 aerial photograph, 1983

| Characteristics | Features | Documentation |
|--|--|--|
| <p><b>Land Uses and Activities</b></p> <p>Includes: Fields, pastures, orchards, open range, terraces, commons, cemeteries, playing fields, parks, mining areas, quarries, and logging areas.</p> <p>*Describe principal and significant land uses</p> <p>*Identify the tangible features related to land uses by type, general location, dates of use, condition and related vegetation</p> <p>*Describe historic processes related to land use, such as mining, irrigation, lumbering, contour farming, or quarrying.</p> <p>*Point out obsolete historic operations, ongoing traditional practices, or modern adaptations related to significance.</p> <p>*Identify threats to integrity, and indicate their location, extant, and impact on historic integrity</p> <p>*Identify areas having major importance or predominance, by location and type, and classify historic or nonhistoric</p> | <p>Fields<br/>Pastures<br/>Vineyard<br/>Orchards</p> | <p>The dominant use of land outside of the UGB is orchards of Christmas trees, and Filbert trees.</p> <p>Also present along the east side of Sears Rd is a small grape vineyard, and smaller fields of row-crop agriculture.</p> <p>Within the UGB of this section is a large golf course and associated, newly constructed, sub-division.</p> |

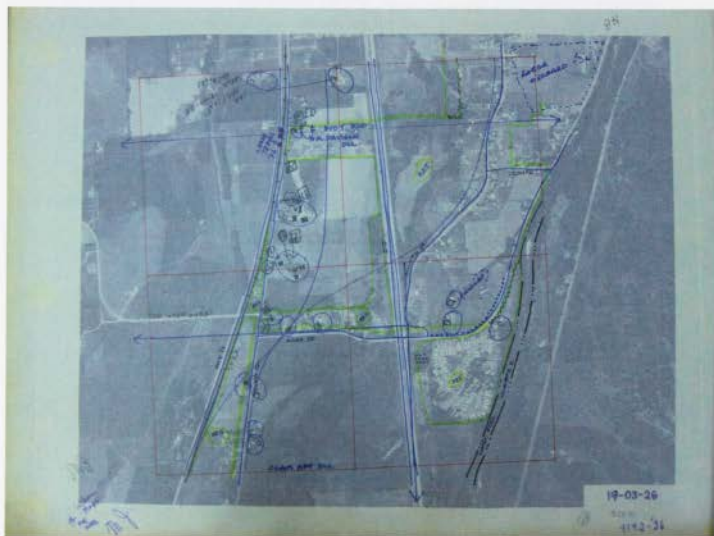
19S.03W.26 aerial photograph, 1983

Generally, the spatial organization, and land use is much the same as it was recorded in the survey completed in 1986. The ratio of open land to forested land is very similar and the spatial organization of structures and areas of vegetation is also largely unchanged. Structures and land use are organized along the major circulation routes. Most of the structures/clusters recorded previously were related to the Landscape of Commerce as the Period of Historic Significance, possibly related to the location of the resources along the major transportation routes. Two of the resources previously recorded cannot be found in presently either due to inaccurate recording or demolition.

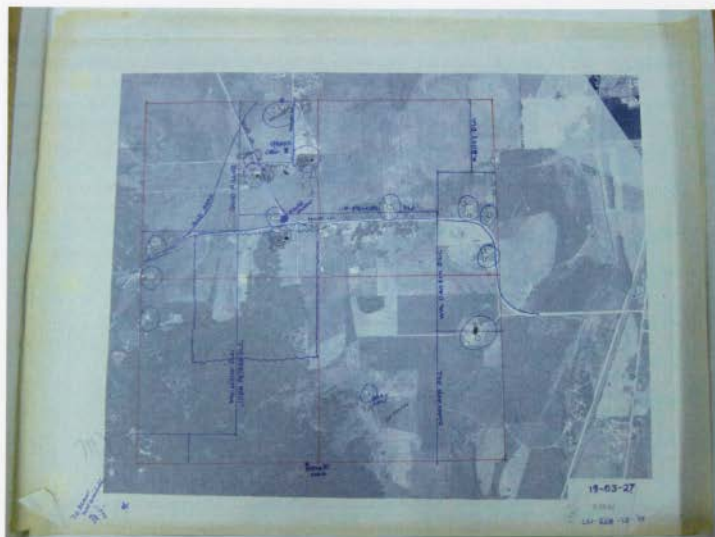
19S.03W.27 aerial photograph, 1983

Land use in this section is a mix of open pastures with livestock and agricultural fields with large field patterns. While there are some new structures built in this section since the survey in 86, they are mostly in the location where there were previously structures on the landscape. Howe Ln., crosses this section from Southeast to Northwest with the concentration of structures located in the center of the section along Howe Ln. The ratio of open land to developed or forested land is very similar to the arrangement seen in the 86 aerial. The patterns of vegetation (open fields with large stands of trees, and tree lines along Howe Ln. and driveways) have all been maintained and are still visible.
